Consolidation of a collar truss with a steel cable system

Giacomo Crivellari^{1, a}, Jorge M. Branco^{1, b}

¹ ISISE - Dept. Civil Engineering, University of Minho

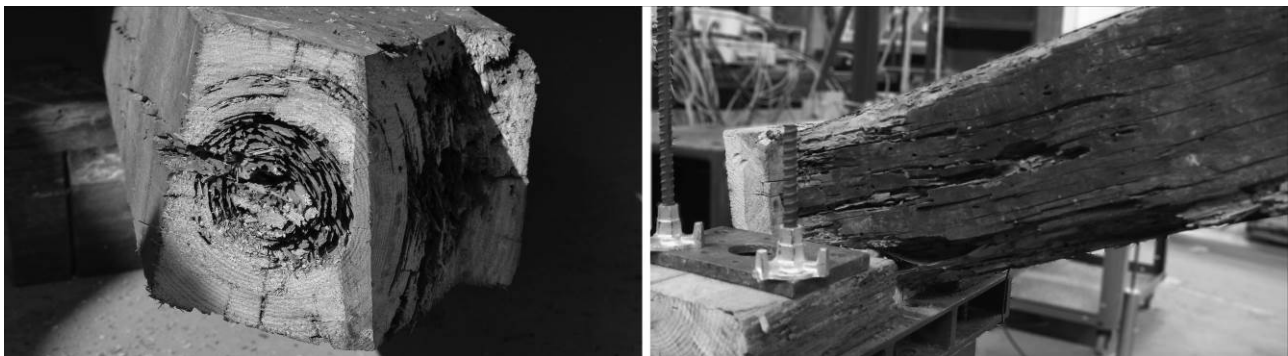
Decay visual mapping. A second step consisted in the identification of the damages present on the truss and their mapping. It was observed that fungi and xylophagus insects affected the wood (Fig. 2). The most deteriorated part was the area closest to the supports, as typically happens in wooden structures embedded in walls. The graphical restitution of the decay was overlapped with the data offered by the consecutive tests, to obtain a crosschecking of the results.

Fig. 2 – Decays affecting the truss in the South support (left) and in the North one (right)

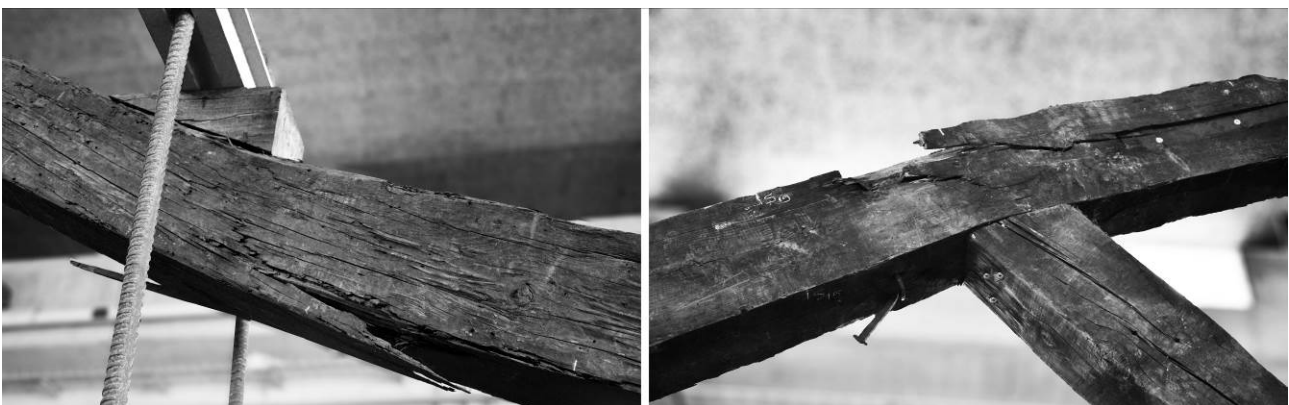
The structure was heavily damaged, with visible fissures in the rafters, located just below the loading points, and in correspondence with the strut – rafter connection (Fig. 4). Many minor cracks appeared all around the truss, and the tie beam joints were significantly opened during the test. The wooden support, separating the rafters from the steel bases, started to crush under the compression stresses. The overall structure showed a tendency of deforming in the out-of-plane direction, with a torsion around the tie beam that affected mainly the upper part of the truss. The deformation is shown in Fig. 5 below. After the test, this latter damage was almost completely reabsorbed by the structure.

Fig. 4 – Fissures in the South rafter in the bottom part (left), and in the strut – rafter joint (right).

After the un-loading of the truss, it was possible to start the repairing operations. Firstly, the cracks over the struts were closed using 500 mm, fully threaded, inox screws. Secondly, the rafters were lifted with the help of a crane, and straightened again. At the same time, the post-tensioned retrofitting system was conceived. It was designed to counteract the bending stresses that was harming the most the structure, and in the meantime transform the imposed load in stresses that could be better borne by the timber elements (see Fig. 6). Some references were found in the state of the art by former realization of other authors [8], but the specific conditions imposed an original design. The basic requirements of the intervention were the *light* approach to the existing elements, a rapid execution with limited budget, and the feasibility of such a technique with real case boundaries (i.e. impossibility to operate from the top for the presence of a roof cover). A fundamental criterion was also the control of the applied prestress. More restriction were imposed by the many obstacles of the set-up and testing system. It was in fact impossible to operate anywhere below the line of the tie beam, considering the presence of all the laboratory devices.

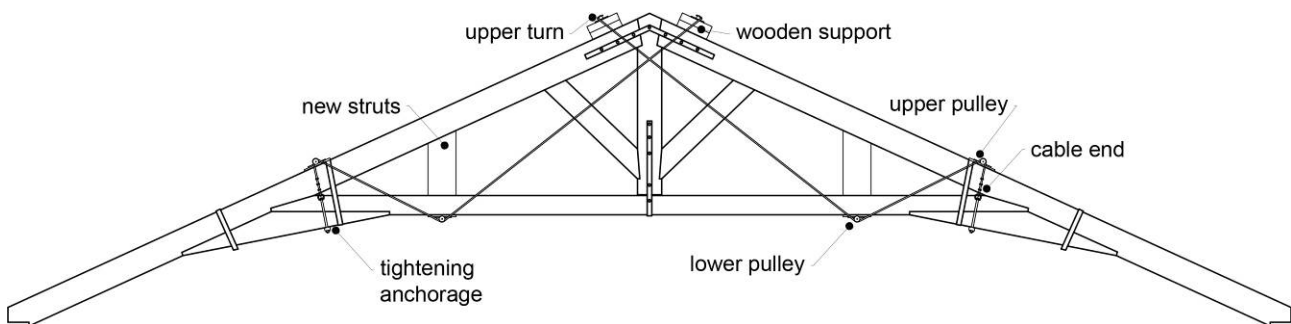
Fig. 6 – Retrofitting intervention

The cable system was twice symmetrical, both to the vertical and longitudinal axis. In fact, all the retrofitting was done with two cables, made with galvanized steel, 14 mm diameter, 6x19 WSC, with ultimate strength of 139 kN. Each line was starting from the *tightening anchorage*, and after some directional changes at the *upper* and *lower pulleys*, it was directed on the other side of the truss passing around the *upper turn* (see Fig. 7). This imply that the retrofitting system was simply laid on the truss, and very few screws were put to fix the elements, making the intervention almost totally reversible. Between the new additions and the historical structure, some wooden sacrificial elements were interposed. All the metal pieces were realized following this specific design, but an accurate choice of commercial sections allowed a drastic reduction of costs and production time.

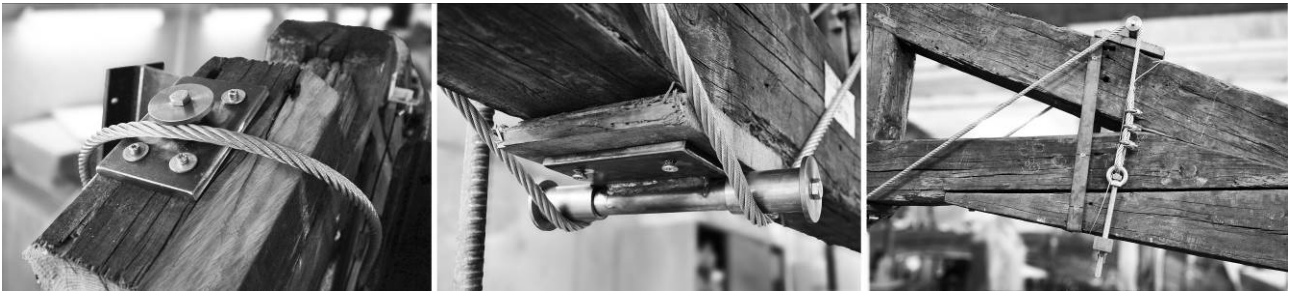
Fig. 7 – Details of the retrofitting. *Upper turn* (left), *lower pulley* (middle) and *anchoring* (right).

The prestresses were induced in the structure through the *anchoring* pieces. Each cable end was tied to a steel ring, connected to a metal threaded rod. These, were firmly kept in position by steel nuts, pushing against a massive metal bar in contact with the truss. While tightening the nuts, the rods were pulling the cables, inducing the necessary tension. With a dynamometric key was possible to evaluate the torsion applied to the system, and with it calculating the axial force in the cables. The post-tensioning was done progressively and as uniformly between the four application points. In total, a prestress of 29 kN was applied in the retrofitting system.

Moreover, new struts were placed just below the loading point, to redistribute the stresses through the whole timber structure. As would be possible to appreciate in the results section, the cable system induced multiples benefic actions on the truss. A part from the main purpose, the counteraction of the loading stresses, the cables helped to tight both the rafters – king post connection, and the tie beam – rafter ones.

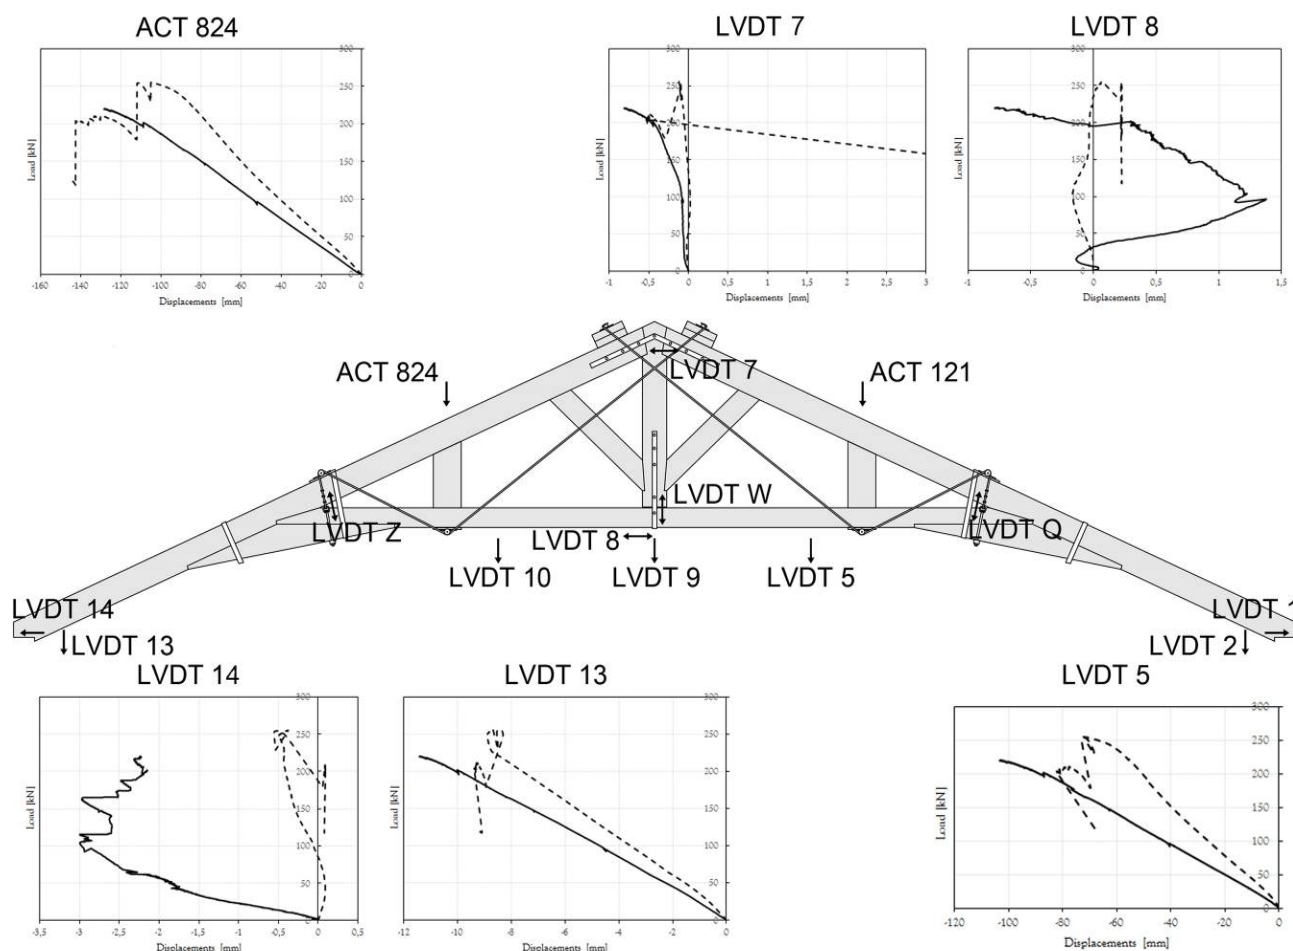
During the second test a maximum load of 220 kN was reached, divided between 108 kN on the South actuator and 112 kN in the North one. The estimation of the goodness of the repairing in terms of load-carrying capacity shows that the structure regained the 82% of its strength, which is a remarkable achievement if compared to the residual state after the first test. It was also noticeable the change in the structural behavior, change that was highlighted from the outputs from the LVDTs set-up (see Fig. 8). Are here presented some significant ones, in order to explain these modifications. The information gathered during the first test are represented through dashed lines, and the second test is drawn with continuous ones. On the horizontal axis are shown the deformation registered by the transducers, expressed in millimeters, while on the vertical direction is shown the total load applied in that moment, in kN.

The data presented have been selected between all the outcomes deriving from both the first and the second test. These information have been qualitatively interpreted to better understand the behavior of the truss during the two experiments. Although the structure was slightly asymmetrical, both in geometry and in the displacement response, the differences were so small to become negligible for the overall comprehension of the tests. The asymmetry is understandable from the graph *LVDT 8*, which shown how the middle point in the tie beam was shifting from one side of the other of the central vertical confinement. The graph *ACT 824* refers to the inner controller of the actuator. During the first test, an abrupt rupture happened, generating the drop after the linear behavior. In the second test, the failure was not achieved, but the graphs shows how the upper rafter was moving more under the same loading. At the same time, the lower part of the structure was also moving faster, as displayed in graph *LVDT 5*. This represents a uniform movement of the whole upper part of the truss, implying an improvement of the stiffness in this area. From *LVDT 13* and *14* is understandable the change in the reactions at the support level. The horizontal thrust was much bigger after the retrofitting, when compared to the first test, and contemporaneously the rafter was rotating more. These modifications imply a less ductile behavior of the upper part of the truss, which consequently loaded more the supports. Eventually, the graph *LVDT 7* is showing the effectiveness of the steel cable system in the confinement of the carpentry joints. The sensor has been placed in the upper part of the connection, and while during the first test there was almost no change in its dimension, in the second experiment it was considerably under the compression effect, generated by the post-tensioning.

Fig. 8 – LVDTs disposition and result comparisons between first (dashed) and second (continuous).
